# Manhole Inspection Summary

Manhole # **S31C\_\_042MH**

Insp Date: **8/18/09 10:32 AM**

**Location** Address: **501 PIERCE ST**

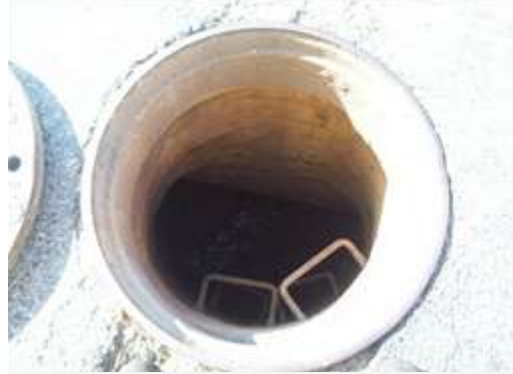
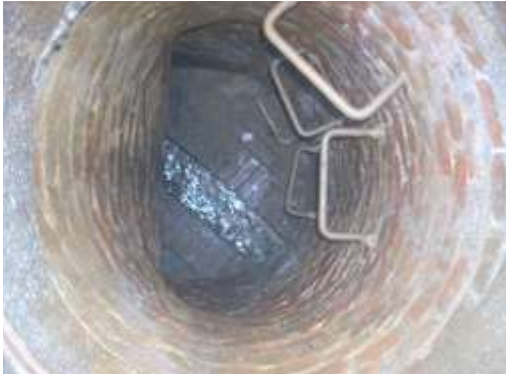
Top View

Comments **Offset manhole, top view can't show the clear connectivity**

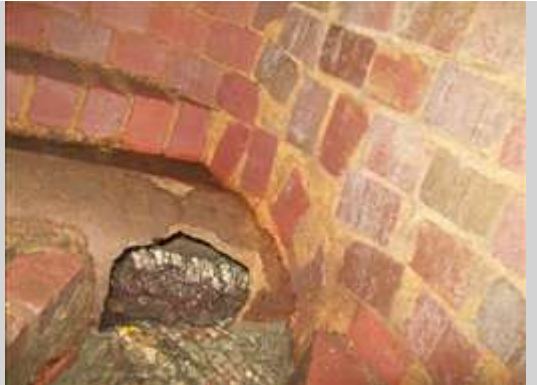
12 O'Clock Outflow

8 in. Circular Gravity Sewer  
Pipe Out @ 12 O'Clock

Invert Depth: **8.80** (ft.) Flow Characteristics: **Fast**

Infiltration: **None** Pipe Seal Cond: **Sound**

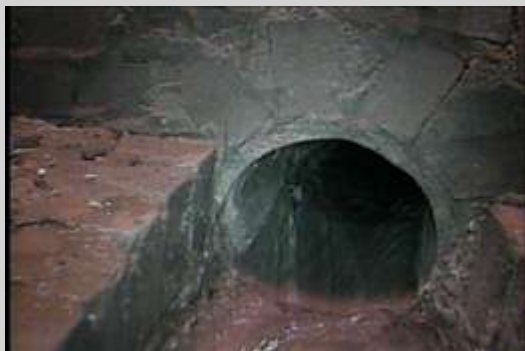
4 O'Clock Inflow

8 in. Circular Gravity Sewer  
Pipe In @ 4 O'Clock

Invert Depth: **8.48** (ft.) Flow Characteristics: **Slow**

Infiltration: **None** Pipe Seal Cond: **Sound**

Connects To: **House connection / Service line**

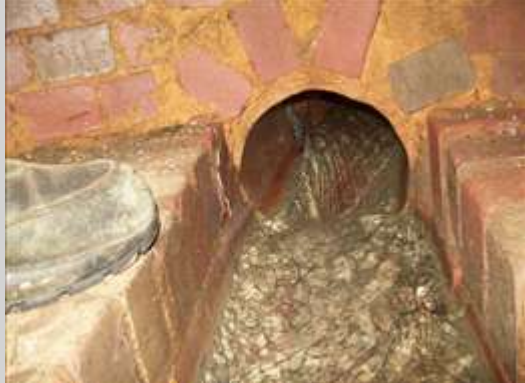
6 O'Clock Inflow

8 in. Circular Gravity Sewer

Pipe In @ 6 O'Clock

Invert Depth: **8.64** (ft.) Flow Characteristics: **Fast**

Infiltration: **None** Pipe Seal Cond: **Sound**
